Manhole Inspection Summary

Manhole # S11U__006MH

Insp Date: **12/9/08 2:49 PM**

Location Address: **1001 Wilso Dr.**

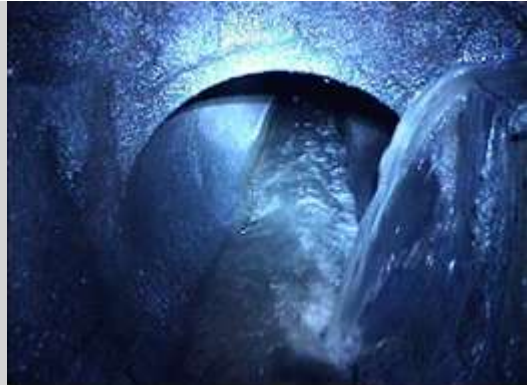
12 O'Clock Outflow

18 in. Circular Gravity Sewer
Pipe Out @ 12 O'Clock

Pipe Height: **18** (in.) Rod and Bar (Angled)
Pipe Material: **Clay** ☐ Pipe Lined
Invert Depth: **20.80** (ft.) Flow Characteristics: **Fast**
Deposits: ☒ None ☐ Mud ☐ Sludge ☐ Debris ☐ Grease
Silt Depth: **0** (in.) Deposits Extent:
Infiltration: **None** Pipe Seal Cond: **Sound**

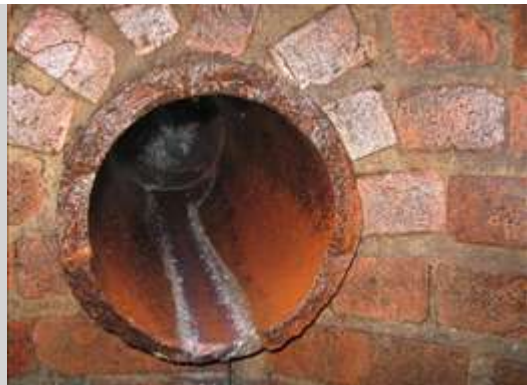
6 O'Clock Inflow

8 in. Circular Gravity Sewer
Pipe In @ 5 O'Clock

Drop In @ 5 O'Clock

Pipe Height: **8.4** (in.) Rod and Bar (Angled)
Pipe Material: **Clay** ☐ Pipe Lined
Invert Depth: **2.25** (ft.) Flow Characteristics: **Fast**
Deposits: ☒ None ☐ Mud ☐ Sludge ☐ Debris ☐ Grease
Silt Depth: **0** (in.) Deposits Extent:
Infiltration: **None** Pipe Seal Cond: **Sound**

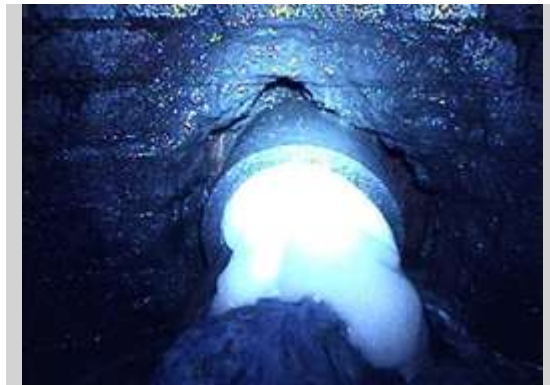
Drop: **Inside** Rod and Bar
Angled: **Yes** Reading: **17.92** (ft.)
Inv Depth: **18.92** (ft.)
Drop Condition: **Open**

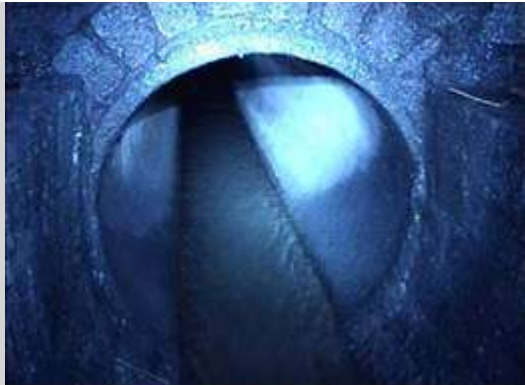
9 O'Clock Inflow

18 in. Circular Gravity Sewer

Pipe In @ 8 O'Clock

Pipe Height: **18** (in.) Rod and Bar (Angled)

Infiltration: **None** Pipe Seal Cond: **Sound**
